NASA Technical Memorandum 4214

Cyclic Hot Firing of
Tungsten-Wire-Reinforced,
Copper-Lined Thrust Chambers

John M. Kazaroff and Robert S. Jankovsky

SEPTEMBER 1990

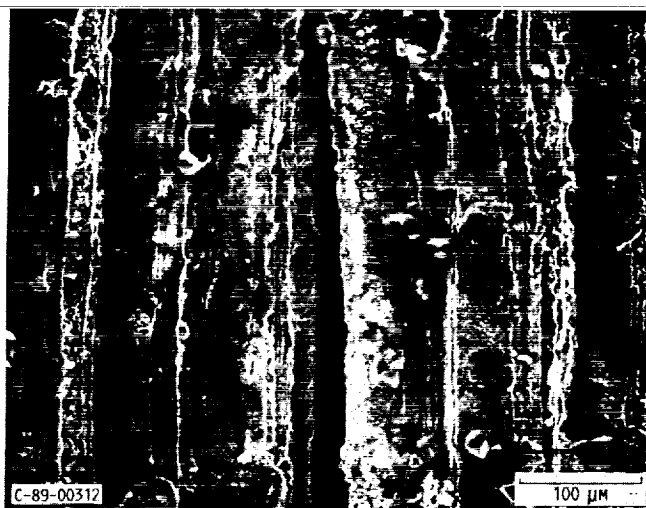
The results for each chamber, although similar, are discussed separately. Chamber 1, which was the first to be fabricated and tested, had the greatest number of thermocouples installed for a complete thermal mapping of the chamber hot-gas-side wall (eight evenly spaced thermocouples located in the throat plane, four located 1.49 cm (0.586 in.) upstream, and four located 1.27 cm (0.50 in.) downstream of the throat). The single failure in the chamber was located in the upstream thermocouple plane exactly between two thermocouples. This through-the-wall crack is shown in figure 8 from the inside chamber wall view.

Figure 8.—Inside chamber wall view of through-the-wall crack in chamber 1.

Also visible in figure 8 are the grooves caused by the final machining of the inside surface of the chamber. Both chambers had identical surface finishes. Figure 9 is an unetched cross-sectional view of these machining grooves. Although they are not considered a major factor, these grooves contributed to the early failures by acting as crack initiators.

5. Before testing, the liner should be polished to remove all machining marks.

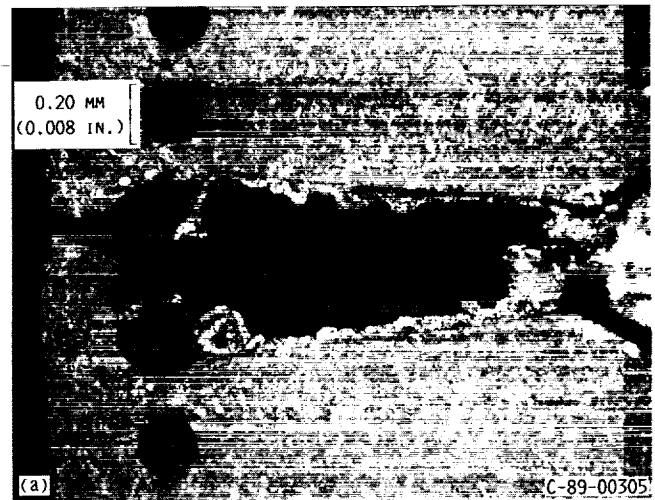
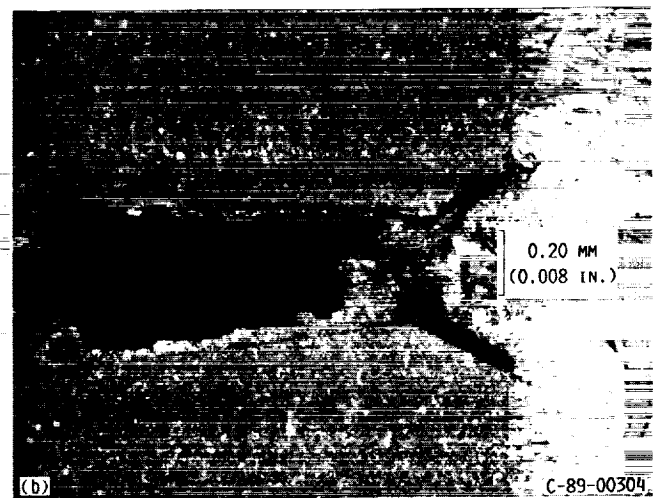
Figure 10(a), which shows the through-the-wall crack, also reveals that the tungsten wires were distorted and damaged at this location and that a large void was exposed above the damaged region. When the specimen was etched to reveal the grain structure and reexamined, electroplated material was found in the void area (figs. 10(a) and (b)). Since the void was so large and the wires were damaged, the drawings and the fabrication process were reviewed. It was discovered that a thermocouple hole was inadvertently drilled in the wrong location. Figure 10 shows that copper was deposited in the exposed hole and sealed up during final electroform closeout. When the thermocouple hole was drilled, the depth was beyond the 0.889-mm (0.035-in.) limit from the hot-gas-side wall, and the drill penetrated into the liner and the reinforcing wires, causing distortion and damage to the wires and leaving a wall thickness of only 0.381 mm (0.015 in.) instead of the 0.889 mm (0.035 in.) required. This damaged, thinner section was determined to be the crack initiation site. With each test cycle, the crack continued to spread in both directions, following a circumferential machining groove until it reached a channel where it fractured and caused hydrogen to leak into the chamber. This explains the early failure of this chamber, especially in a cooler region than the throat area, where failure was not expected. Once this was discovered the failure analysis of chamber 2 was begun.

(a) Showing wire damage and large void.
(b) Showing copper deposited in thermocouple hole.
Figure 10.—Cross-sectional views of crack in chamber 1.

3. Thermocouple holes should either not be used or be moved back away from the liner material to eliminate them as possible early failure sites.

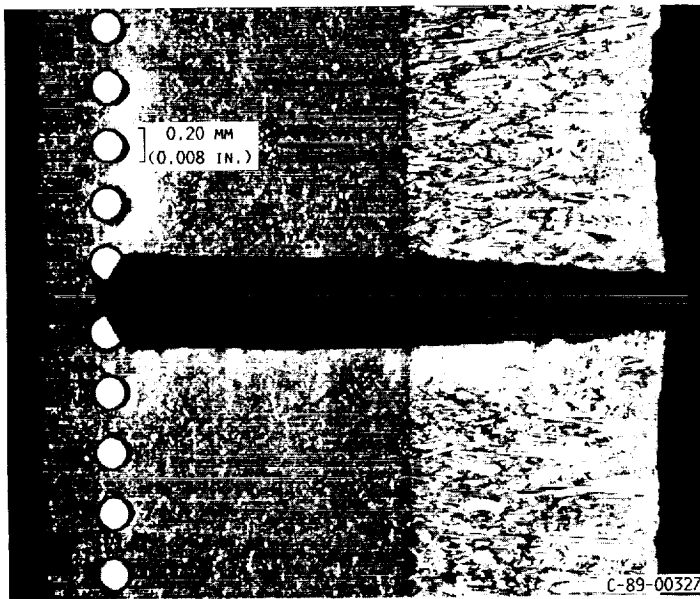
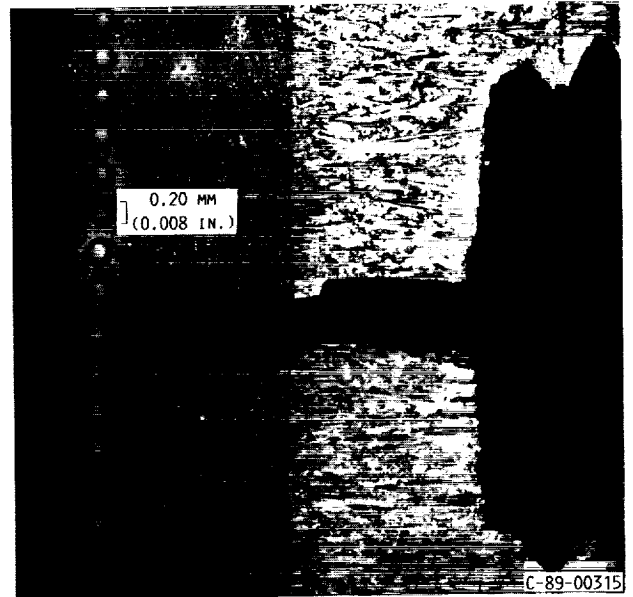
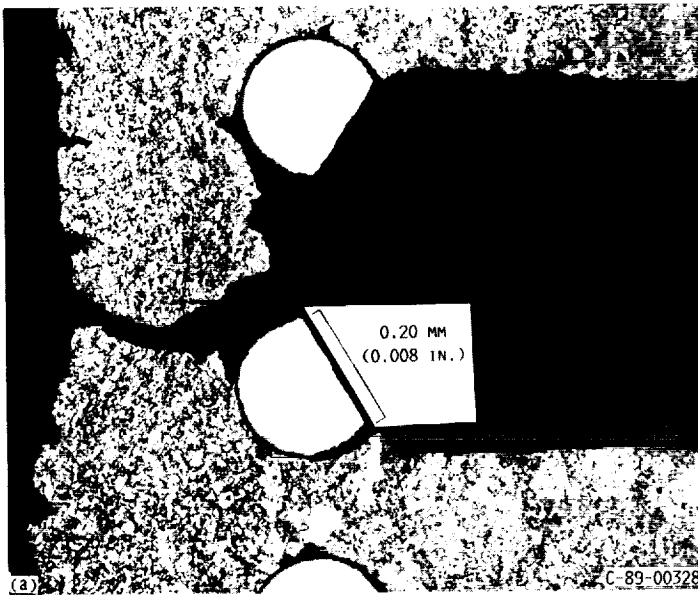
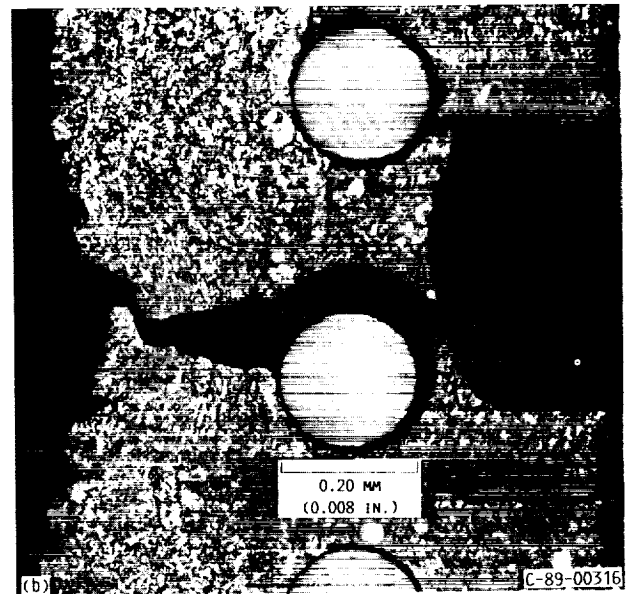
There were three crack locations on chamber 2, all in the throat plane. These cracks, designated here as cracks A, B, and C, are shown in figure 11. Sectioning and polishing revealed that all three crack sites were associated with a thermocouple hole. In all cases the holes were drilled to a depth greater than required and were the cause of early failure. Figure 12 shows cross-sectional views of cracks A and B. The views shown for crack C in figures 13 and 14 are different because this specimen was polished from the back side toward the wires rather than cross sectionally. Figure 13 shows the thermocouple hole and the crack leading from it in an area above the reinforcing wires, and figure 14 shows the damaged area after it had been polished further to expose the wires. There is no question that the cause of these failures was thermocouple hole penetration into the composite liner material.

Figure 12.—Cross-sectional views of cracks A and B.

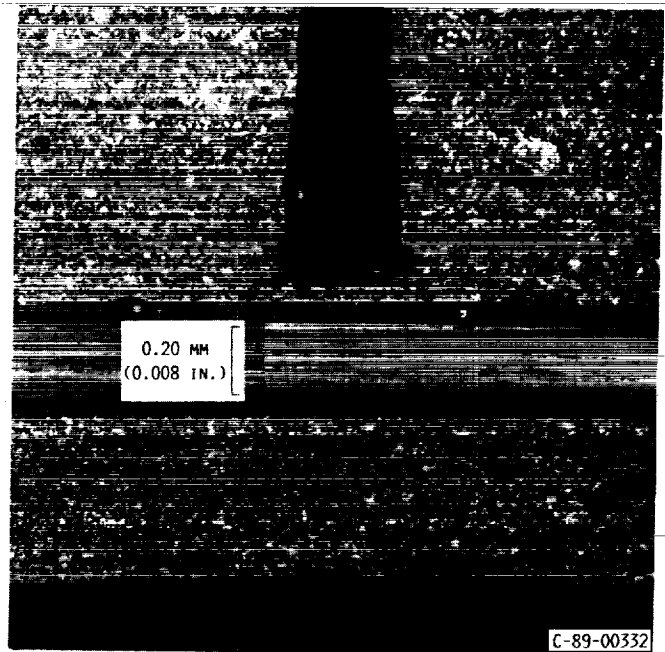
Figure 15.—Chamber 1 specimen from nonfailed thermocouple location.

Since a number of specimens were available, a sample from chamber 1 was prepared at a nonfailed thermocouple location (fig. 15). Here again the thermocouple hole was deeper than required, but since this location was not in the hotter throat plane, there was less thermal strain. Figure 15 also shows that

the copper was not bonded to the tungsten wire, possibly indicating a limited amount of load sharing. This lack of bonding can be seen again in figure 16, cross-sectional views of a series of wires. The specimen shown in figure 16 was also taken from chamber 1 in a region remote from the throat area.

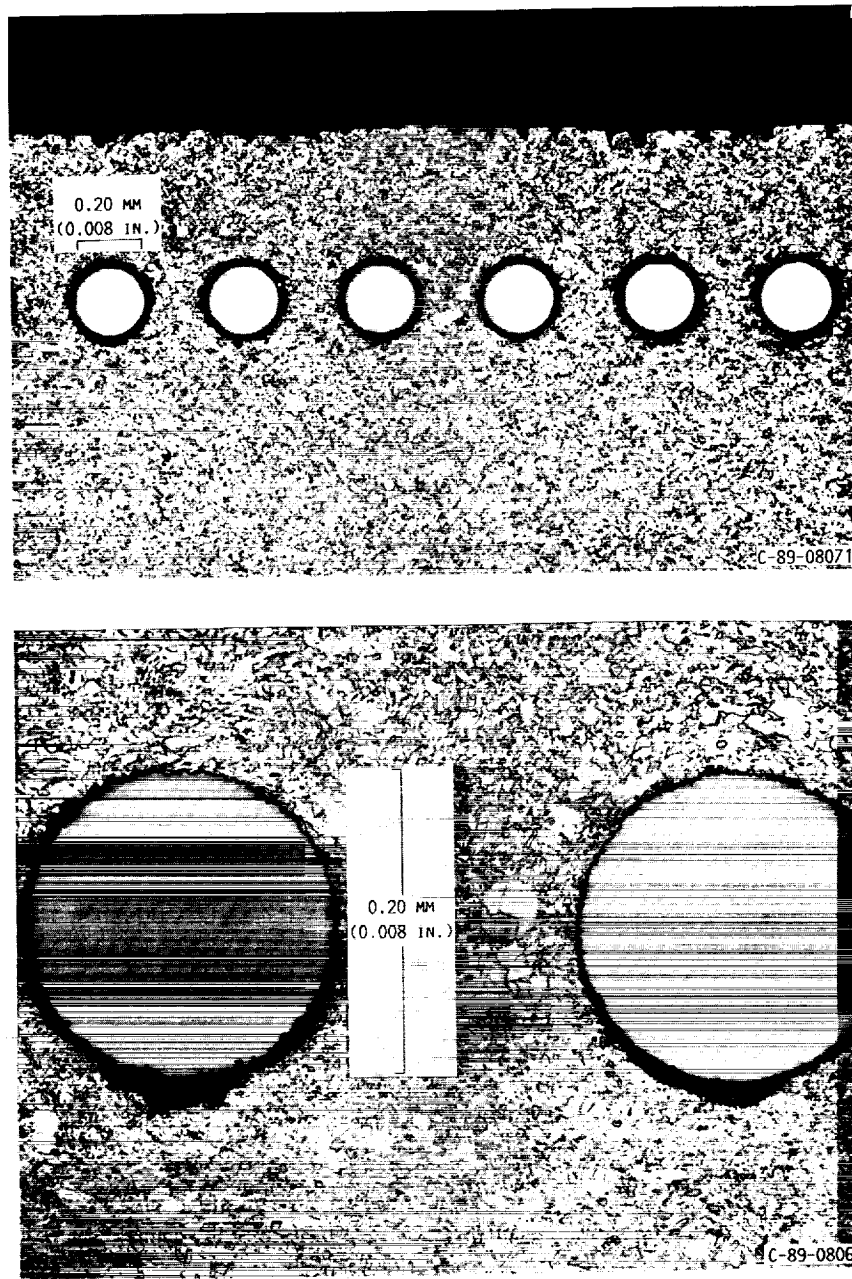
Figure 16.—Cross-sectional views of chamber 1 showing lack of bonding between tungsten wires and copper alloy.

4. The tungsten reinforcing wires should be cleaned and precoated in order to enhance bonding with the copper alloy. Coatings such as plated silver or copper could be used to protect the surface of the tungsten wire during processing and would readily diffuse when HIPed.
